PRIMARY RECORD

* Resource Name or #: 2406 Dulzura Avenue, APN 539-041-11

BUILDING, STRUCTURE, AND OBJECT RECORD

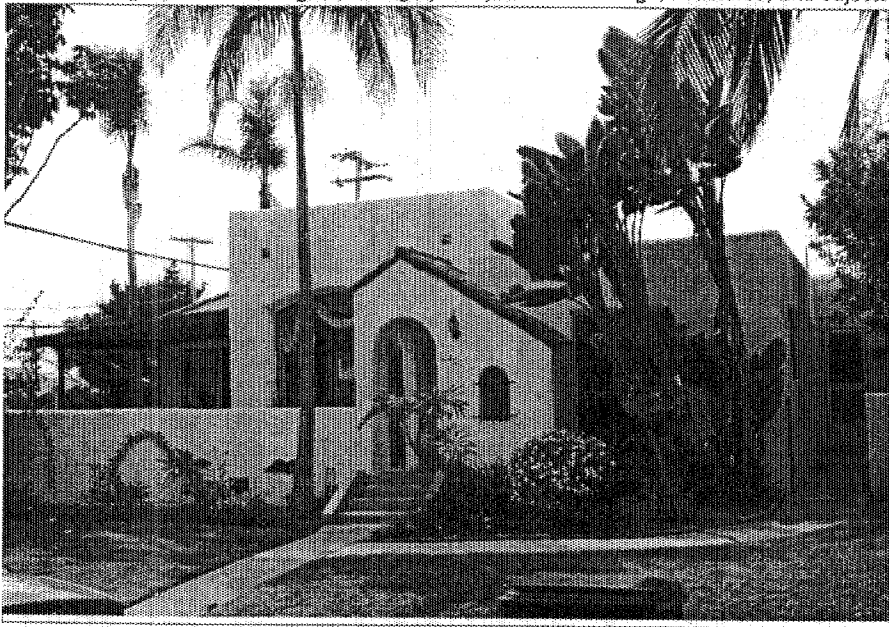
Photo Number: P0003082.JPG Est. Date: 2001

* P3a. Description: (Describe resource and its major elements. Include design, materials, condition, alterations, size, setting, and boundaries.)
This house was built in 1950 in the Spanish Colonial Revival style. The house is one story with four vertical divisions: a shed roof with tile roofing on the first division, a high flat roof with a parapet wall on the second division, a saltbox projection entryway with tile roofing on the third division, and a lower flat roof with a parapet wall on the fourth division. The main entry projects out with arched openings to the main walkway and to the adjoining porch, which wraps around the side of the house. The north side of the porch has a faux balcony and a rectangular fixed window. The entry is flanked by a three section, fixed glass, low-point arch window. Other windows, except for one, are wood casement. The second division has two single square decorative designs in high relief. Some early wrought iron-work is apparent on the small arched entryway, the faux balcony, the gate, and the side windows. The garage is along the side setback and also has a flat roof and parapet wall design. The house is located in the community of Burlingame. It is in good condition. The total usable floor area is 1,922 square feet. The house features 3 bedrooms and 1 bath. The total lot area is 6,100 square feet. It is located on a corner lot.

1920'S was the date of construction estimated from the field survey. Real estate data from TRW-Experian, based on Assessor's information, indicates that [19]50 was the date of construction. This house appears to have an early shell and m

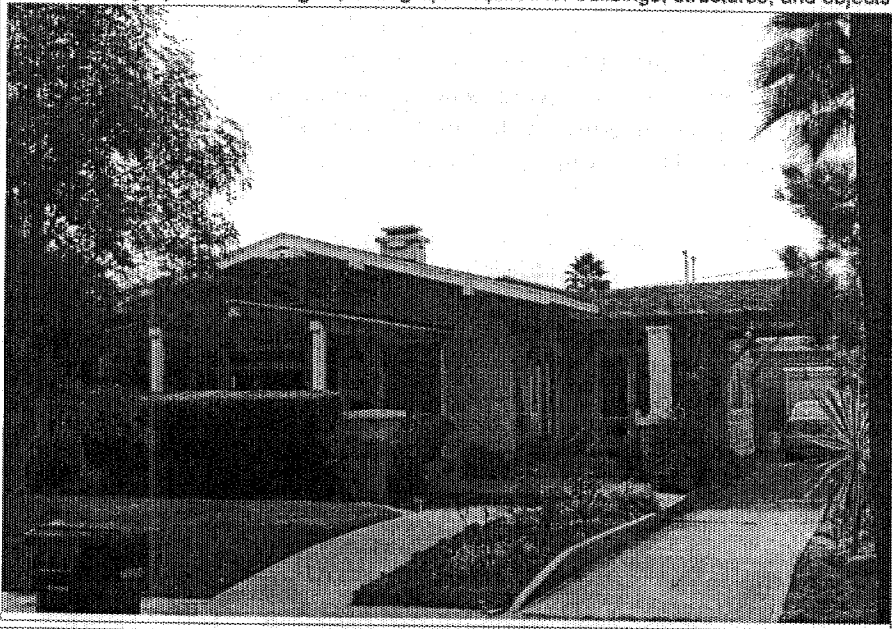
Photo Number: P0003081.JPG Est. Date: 2001

* P3a. Description: (Describe resource and its major elements. Include design, materials, condition, alterations, size, setting, and boundaries.)
This house was built in 1912 in the Craftsman Bungalow style. The house is one story with a low-pitch cross-gable roof with wide projections held by 4"x4" beams. The side gable is supported at the corner by wood bracings. The exterior wall material is a patterned wood shingle design. The front porch appears to be a later addition and is held by 4"x4" beams, posts, and chains hanging from the rafters. The entryway door is off-set with multi-lights and flanked by a large three section Craftsman style window. A side entry door is located on the opposite side. All windows are original Craftsman design wood framed. A trellis extends from the side of the front-facing gable to form a porte cochere supported by square wood pillars on stucco piers. The trellis may be a later addition. The rear one car garage has a flat roof and maintains a similar wood shingle design. The house is located in the community of Burlingame. It is in good condition. The total usable floor area is 1,542 square feet. The house features 3 bedrooms and 1 bath. The total lot area is 6,100 square feet.

1920'S was the date of construction estimated from the field survey. Real estate data from TRW-Experian, based on Assessor's information, indicates that [19]13 was the date of construction. Additional historical information, including construction date, obtained from: Covington, Donald Patrick, "Burlingame: The Tract of Character 1912-1929". Park Villa Press, San Diego, 1997.

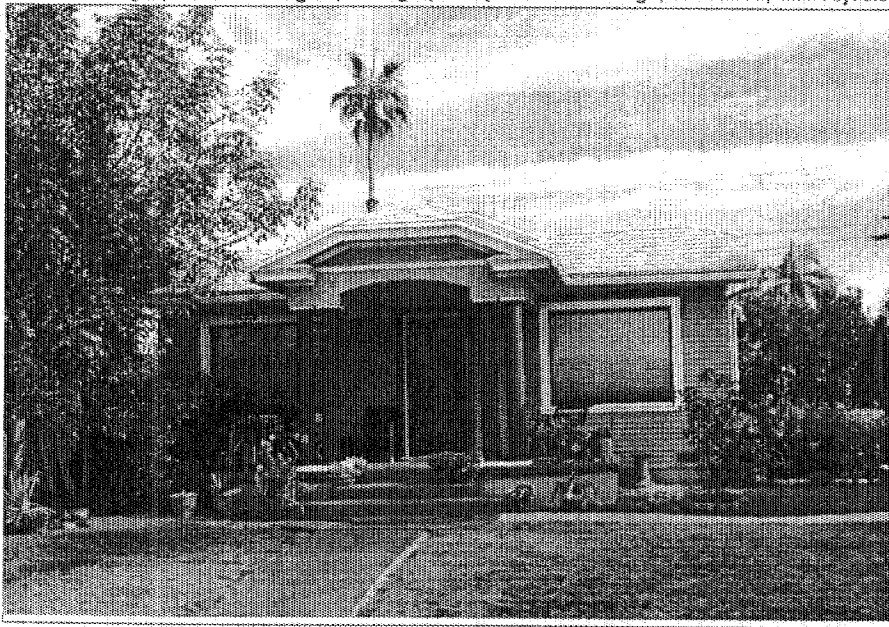
Photo Number: P0003084.JPG Est.

* P3a. Description: (Describe resource and its major elements. Include design, materials, condition, alterations, size, setting, and boundaries.)
This house was built in 1932 in the Colonial Revival style with neo-classical elements. The house is one story with a Jerkinhead hipped roof and gable and an eyebrow vent behind the portico. The exterior wall material is horizontal wood clapboard. The portico has a Jerkinhead roof with cornice returns and is supported by double columns. The open porch has a centralized entryway with a wooden door and a decorative glass center. The entryway is flanked by large single pane windows. The house is located in the community of Burlingame. It is in good condition. The total usable floor area is 1,094 square feet. The house features 2 bedrooms and 1 bath. The total lot area is 6,300 square feet. Other improvements on the property include a detached garage.

1920'S was the date of construction estimated from the field survey. Real estate data from TRW-Experian, based on Assessor's information, indicates that [19]32 was the date of construction, with effective improvements dating from [19]35.

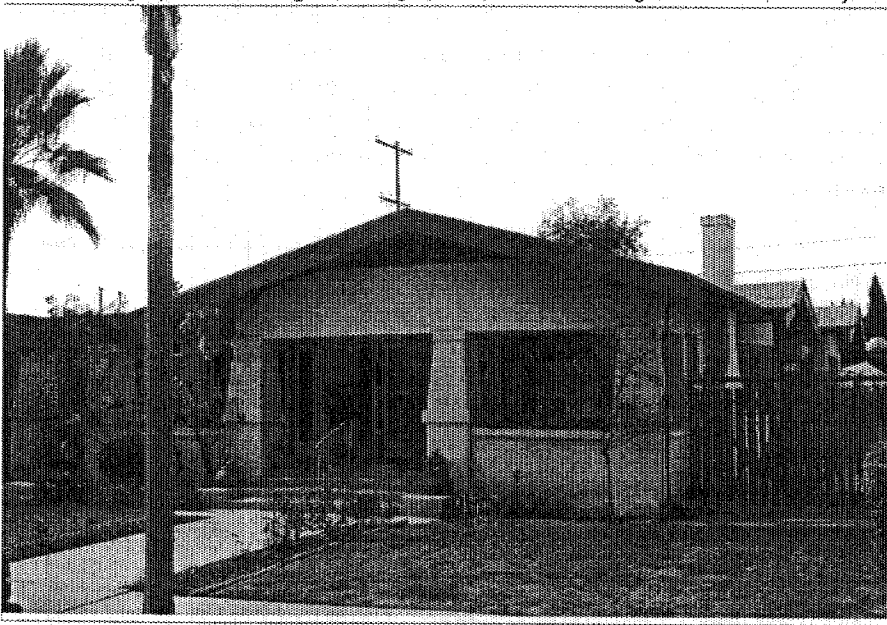
Photo Number: P0003080.JPG Est. Date: 2001

* P3a. Description: (Describe resource and its major elements. Include design, materials, condition, alterations, size, setting, and boundaries.)
This house was built in 1922 in the Craftsman Bungalow style. The house is one story with a low pitch gable roof, composite shingles, large vents, and multiple side bays. Fascia is punctuated by large tapered beams. The front porch is supported by large tapered stucco piers on shorter rectangular stucco pillars joined by a low parapet wall. A heavy beam trellis extends outward from the porch to form a porte cochere. Windows appear to be original Craftsman style wood windows with multi-light diamond detailing on top. The diamond detail glazing is reflected in all of the windows. The entryway door has sidelights and is flanked by full light casement windows. The rear garage has barn-style doors and is consistent with the design of the house. The house is located in the community of Burlingame. It is in good condition. The total usable floor area is 1,824 square feet. The house features 3 bedrooms and 1 bath. The total lot area is 6,100 square feet.

1920'S was the date of construction estimated from the field survey. Real estate data from TRW-Experian, based on Assessor's information, indicates that [19]22 was the date of construction.

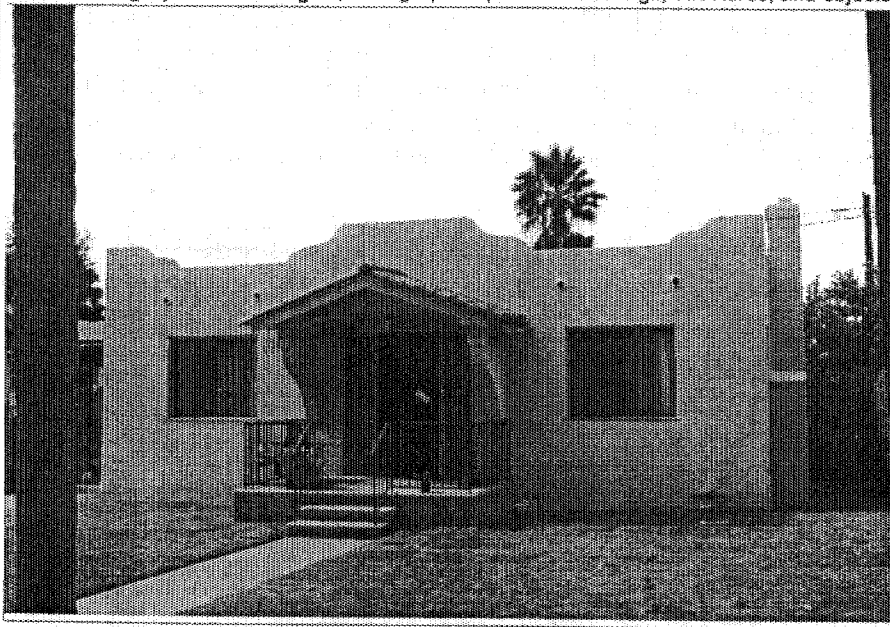
Photo Number: P0003079.JPG Est. Date: 2001

* P3a. Description: (Describe resource and its major elements. Include design, materials, condition, alterations, size, setting, and boundaries.)
This house was built in 1934 in the Mission Revival style. It is a one story house with a flat roof, curvilinear parapet walls with corbelled ends, and a large tapered brick chimney on the side of the house. The exterior wall material is stucco with circular terra cotta drains. The porch is centered and partially covered by a front-gable pediment supported by heavy stucco brackets. The entryway is flanked by aluminum windows. Wrought iron security bars detract from the design, but are removable. The single-car garage toward the rear of the house is consistent with the design of the house. The house is located in the community of Burlingame. It is in good condition. The total usable floor area is 1,156 square feet. The house features 3 bedrooms and 1 bath. The total lot area is 6,100 square feet.

1920'S was the date of construction estimated from the field survey. Real estate data from TRW-Experian, based on Assessor's information, indicates that [19]34 was the date of construction.
